Kazimierz Darowicki

MAJOR APPLIED RESEARCH AND IMPLEMENTATIONS

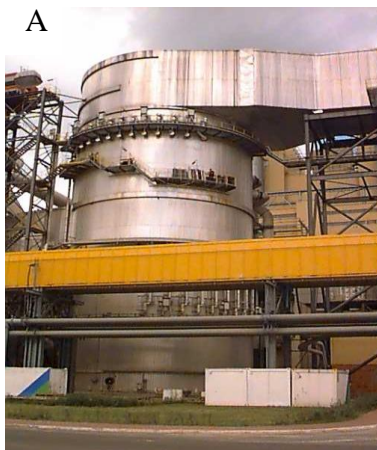
Photo. 2.1. (a) Absorber, (B) Scheme of absorber structure, (C) Hardness measurement of rubber lining, (D) Scheme of measurement cell, (E) Measurement cell on tested rubber lining, (F) Collected impedance spectra for penetrated lining (outlet duct) and unpenetrated lining (bottom part of absorber)

Flue gases contaminated with SO_2 are fed through the duct to the absorber and sprayed with limestone slurry (Photo. 2.1B). Air is introduced in the oxidizing zone of the absorber, and gypsum is produced. The absorber walls are lined with two layers of protective rubber (Photo. 2.1C). Unfortunately, after some time, the rubber lining is destroyed and loses its protective properties. Due to the different corrosion hazards in particular zones, the level of lining destruction varies.

The research determined the reasons for the limited durability of rubber linings. A non-destructive impedance method for assessing the condition of rubber liners has been developed. The idea of measuring the impedance of a rubber lining is presented in the Photo. 2.1D. Photo. 2.1E shows the operating measurement cell. By measuring impedance in selected locations, hydration profiles of rubber linings were obtained. Photo. 2.1F presents an impedance spectrum indicating good barrier properties of the lining and an impedance spectrum of the penetrated lining. Using an impedance method for assessing the condition of linings, a system of rational planning of renovation periods and the extent of individual absorbers was created. The described research methodology was one of the first field applications of electrochemical impedance spectroscopy in the world. The proposed solution was published and received a very high rating from the Belchatów Power Plant and the company carrying out anticorrosion works.

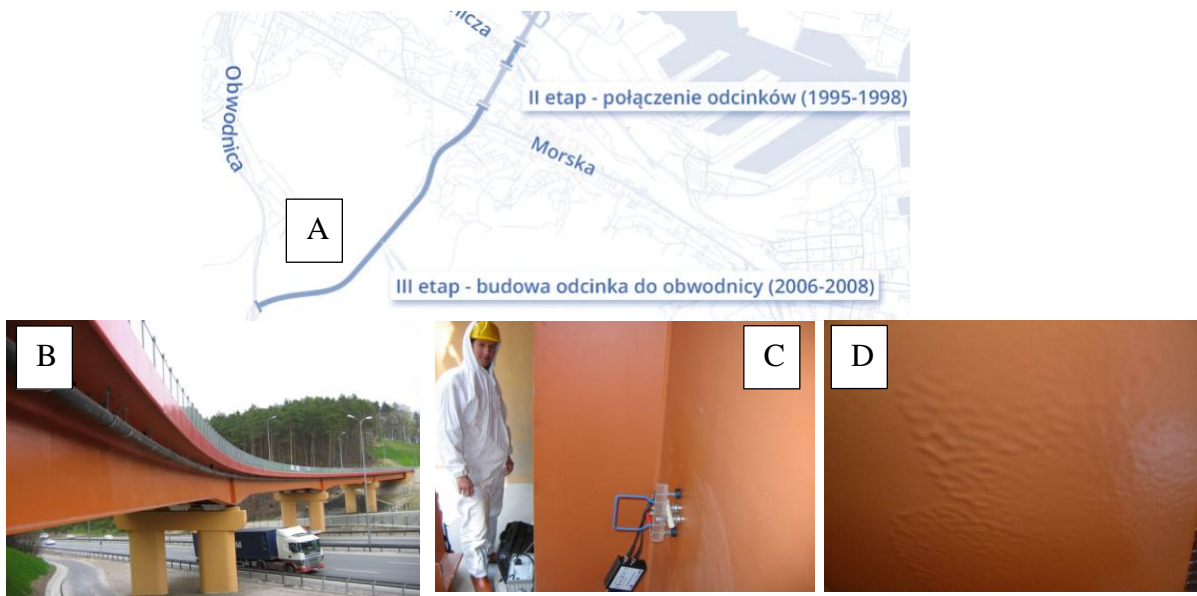
Photo. 2.2. (A) The course of the Kwiatkowski Route, (B) The view of the overpass over the ring highway, (C) Impedance measurements of the condition of the coating system, (D) Defects of the anticorrosion coating

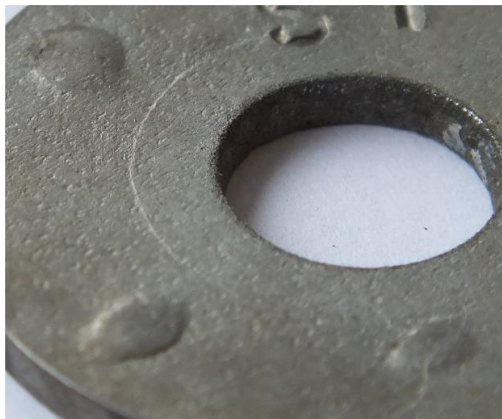
Photo. 3.3-1. Image of hydrogen blisters

The investigation results of the Catalytic Cracking II installation indicated periodically elevated hydrogen content in the steel, even exceeding the level of 6 ppm per month. Blisters have been found, which are the result of hydrogen ingress into the microcrystalline lattice of steel.

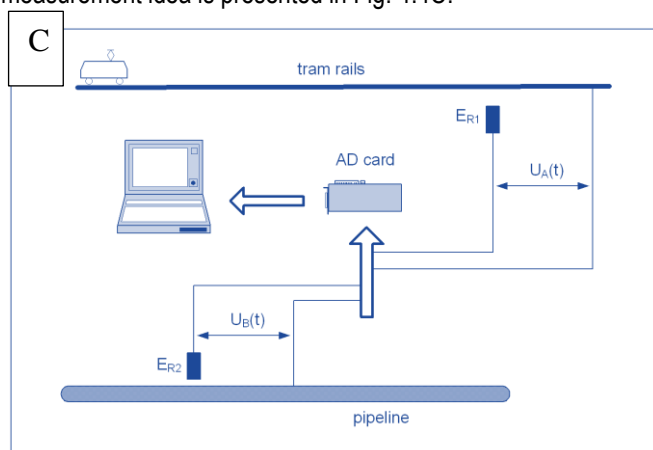
Fig. 4.4. (C) Scheme for simultaneous recording of current interactions, (D) STFT spectrograms of the rail potential change register and the gas pipeline potential change register.

Stray currents can be evaluated and recorded using advanced metrological technology. However, the interpretation of measurement data is often ambiguous. In order to assess the stray currents risk, it is necessary to identify the source of currents and the place of their leakage. For this purpose, a digital method based on time-frequency analysis was developed. The measurement idea is presented in Fig. 4.4C.

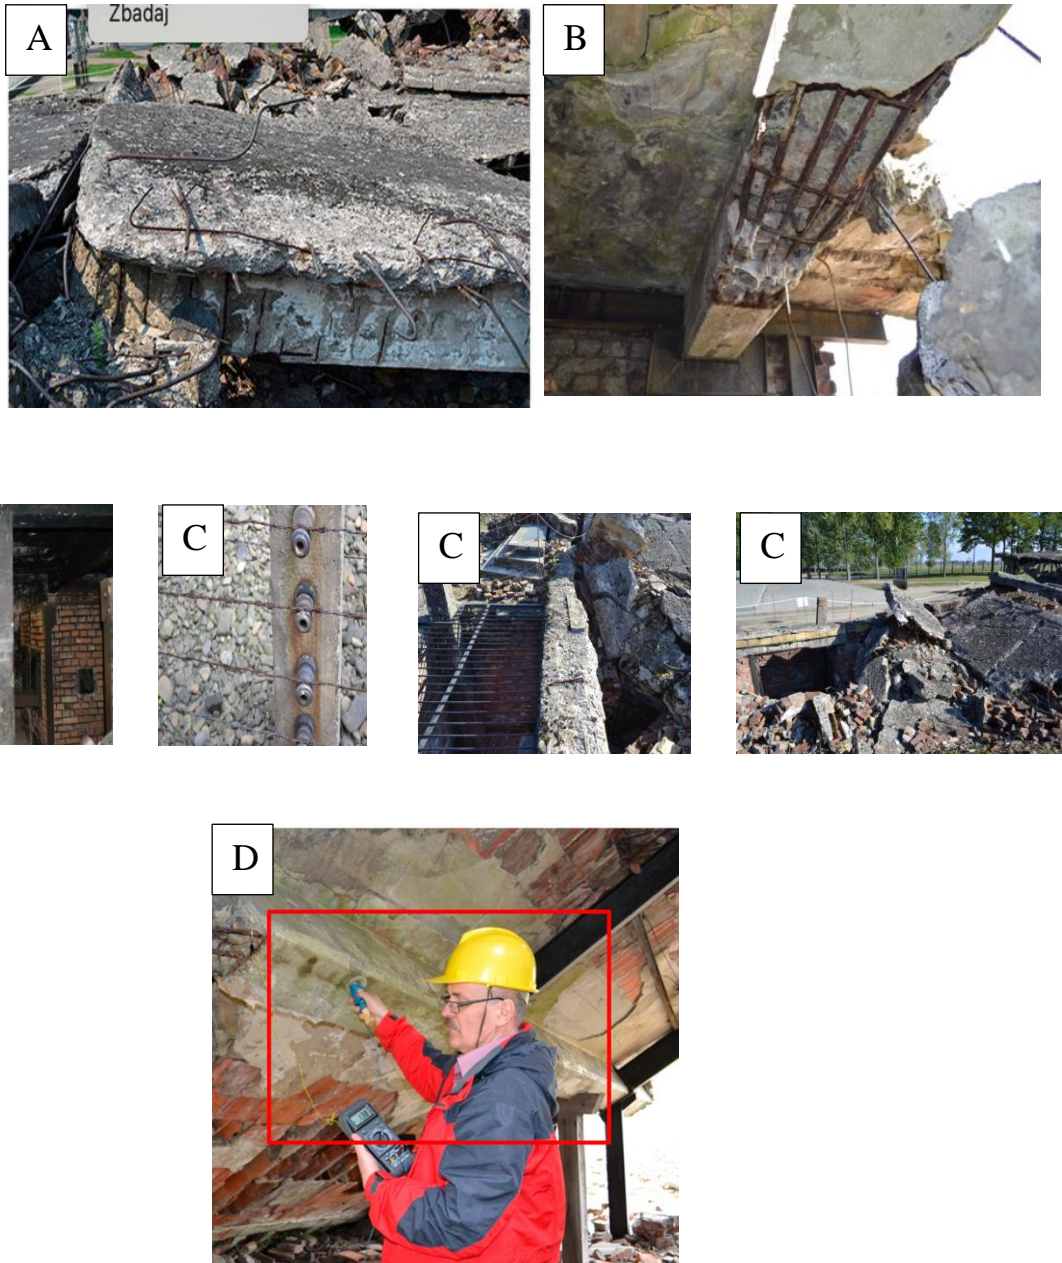
Photo. 4-5. (a) Exposed reinforcing bars of the ruins of crematorium no. 2 in Auschwitz II-Birkenau, (B) Ceiling of the gas chamber of this crematorium, (C) Typical forms of damage to concrete structures, (D) Recording a map of electrochemical potential on a reinforced concrete ceiling beam inside the ruins of crematorium no. 2 in Auschwitz II-Birkenau

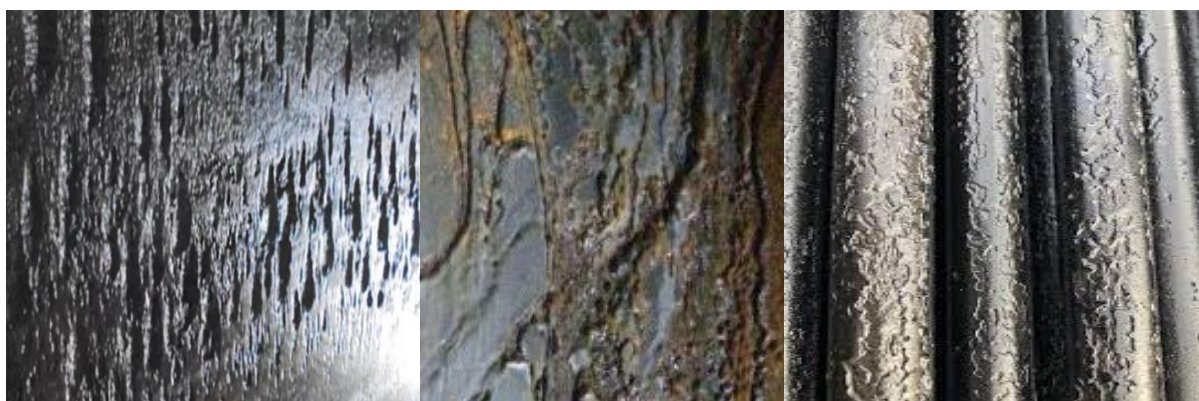
Photo. 4.7. Forms of damage to amine washing installations

The amine installations consist of an absorber for removing CO₂ and H₂S from the acid gas stream and a regenerator for the purification of the amine. Therefore, the amine operates in an almost closed circuit in which it is constantly recycled and reused. The added amine and water compensate for losses from the top of the regenerator. Common causes of failures in amine systems are related to the complexity of amine washing installations. These installations are subject to various types of attacks. Photo. 4.7 presents the images of corrosion damage.

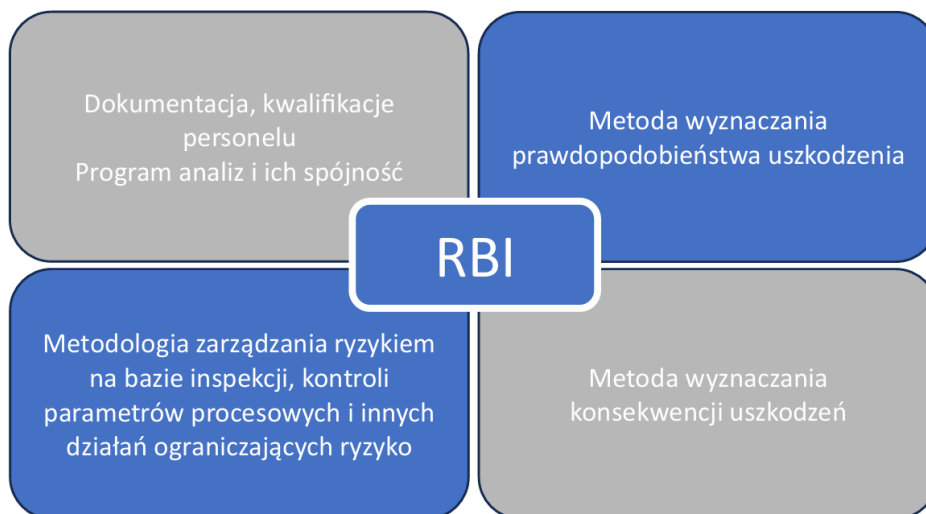
Fig. 4-10. A diagram illustrating dependencies and relationships in the created RBI system

The above-mentioned standards create a system presented in the form of a diagram.

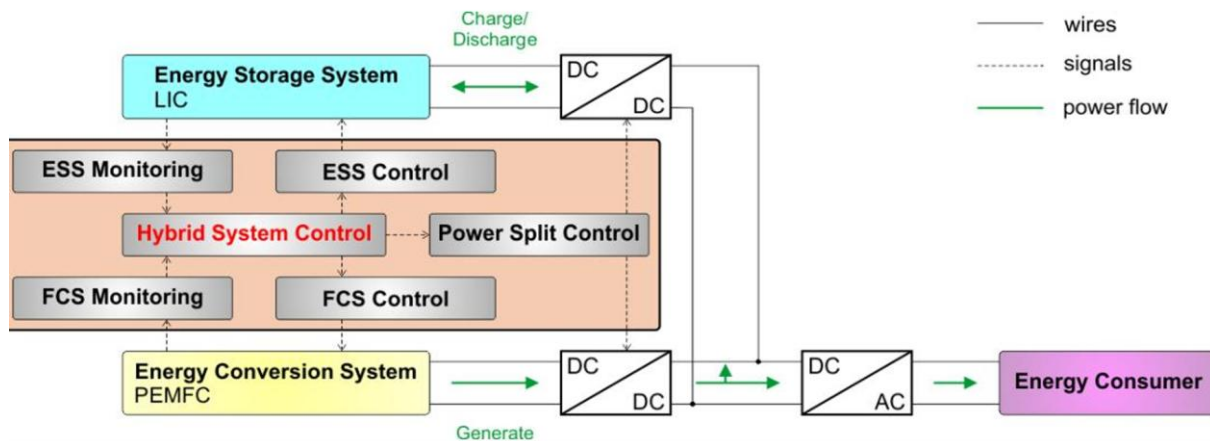
Fig. 4.11A. PEMFC-LiC hybrid system and its control

The research and development work engulfed a controller and control algorithms for a hybrid system, including a power reserve storage, which was a package of supercapacitors, and a stack of hydrogen cells with a polymer membrane (PEMFC), along with the entire flow and operating temperature management system. The developed solution ensured an increase in energy efficiency by 3.7% while reducing the mass of the system. This work was carried out in cooperation with the Zentrum für Sonnenenergie- und Wasserstoff Forschung Baden-Württemberg (ZSW) Germany, the Deutsches Zentrum für Luft- und Raumfahrt eV (DLR) Germany, the PowerCell Germany GmbH. Poland was represented by the IMPACT Clean Technology and the Faculty of Chemistry, which coordinated research on the Polish side. Renewable energy systems have been extensively studied in the last decade to reduce fossil fuel-based energy supplies and reduce CO₂ emissions. Research focused on improving the efficiency, reliability, and energy density of these systems. Fuel cells are widely promoted in the energy conversion system due to their high efficiency, low or zero emissions, and high power density. One of the factors implying the development of fuel cell technology is their efficiency, which reaches 60% while the efficiency of internal combustion engines is 30%. Unfortunately, the operational dynamics of the cell stack is unsatisfactory. PEMFC fuel cells are the most promising candidate due to their high flexibility and highest dynamics among fuel cells. Nevertheless, the transient response of PEMFC is limited by the rate of electrochemical reaction and the dynamics of reactant supply. In practical applications, PEMFC fuel cell systems are used as the primary source of energy conversion, with peak power demands being met by additional energy storage systems such as batteries or capacitors. The hybrid system's response to transition states is a major challenge for automotive and mobile applications. The capacitor-based energy storage system offers a number of advantages, such as higher energy density, power density, and dynamics compared to battery solutions. A lithium-ion capacitor (LiC) is the most modern supercapacitor that has very high energy density and very little leakage compared to other capacitors. The application of LiC allows the use of PEMFC covering only average power demand, not peak one. This results in a higher power density of the hybrid system. The operation of such a fuel cell-based hybrid system requires coordinated control of the energy generation subsystems and energy storage by the control unit. This unit provides rapid response to variable power demand and avoids destructive and suboptimal operating conditions. The developed and implemented control algorithm ensured the coordination and cooperation of particular components. Independently, a system has been created to monitor and control the operation of the controller in accordance with the diagram:

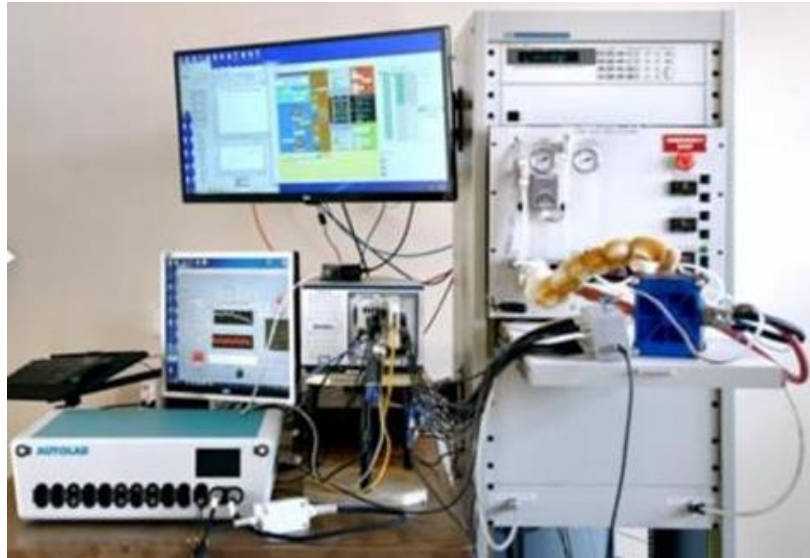
Photo. 4.11B. Digital Dynamic Electrochemical Impedance Spectroscopy measurement system based on National Instruments measurement cards coupled to a hydrogen fuel cell test bench.

available at AVL LIST GmbH – THDA box23. As part of collaborative work, a prototype of a controller for a hybrid fuel cell system was developed. It took advantage of the SAE J1939 industrial automotive protocol, which uses a physical CAN bus. In this way, fuel cell systems intended for a specific application can be transferred to other applications. Stack condition was monitored with DEIS. A quick analysis of the complex response of the system allows determination of the impedance of the system at different frequencies of perturbation signals that make up the pack. This method saves the acquisition time of the impedance spectrum. For this reason, this original measurement method gave excellent results in monitoring systems subject to dynamic changes. This innovative and proprietary technique has proven itself in monitoring PEMFC stacks while working in a real system.

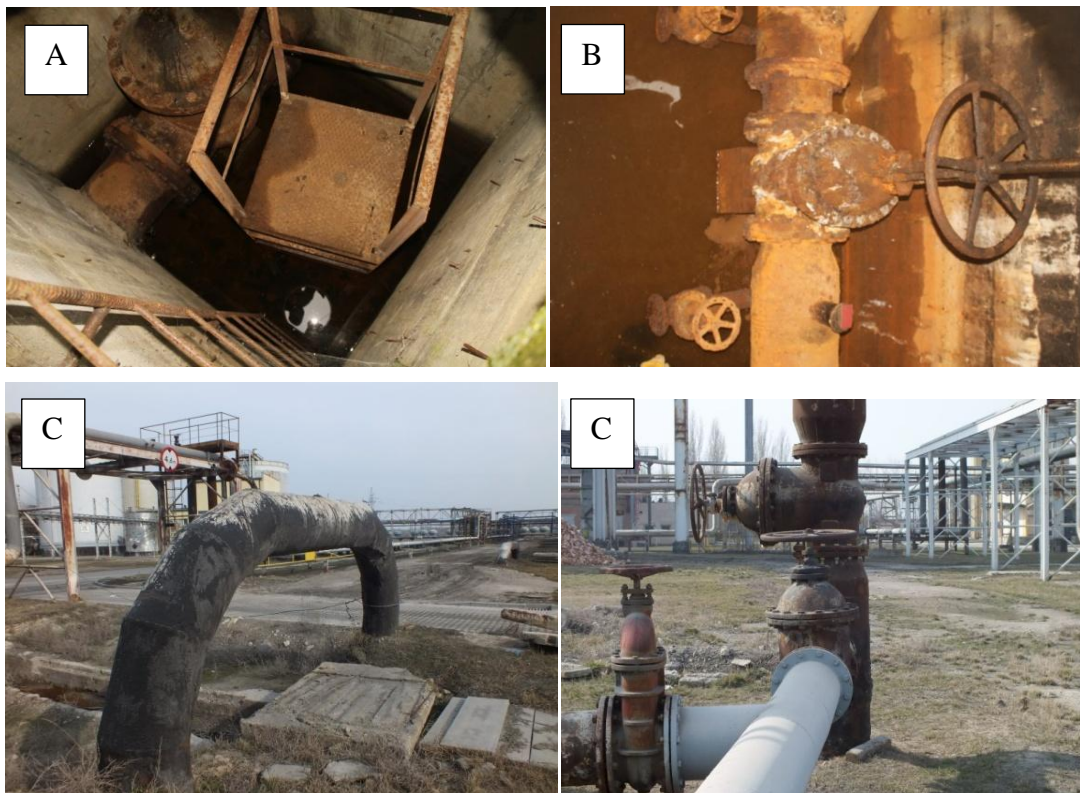
Photo. 4-13. (A) Condition of exemplary inspection chamber, (B) Corrosion condition of the fittings (gate valve), (C) View of the surface parts of the transport pipelines

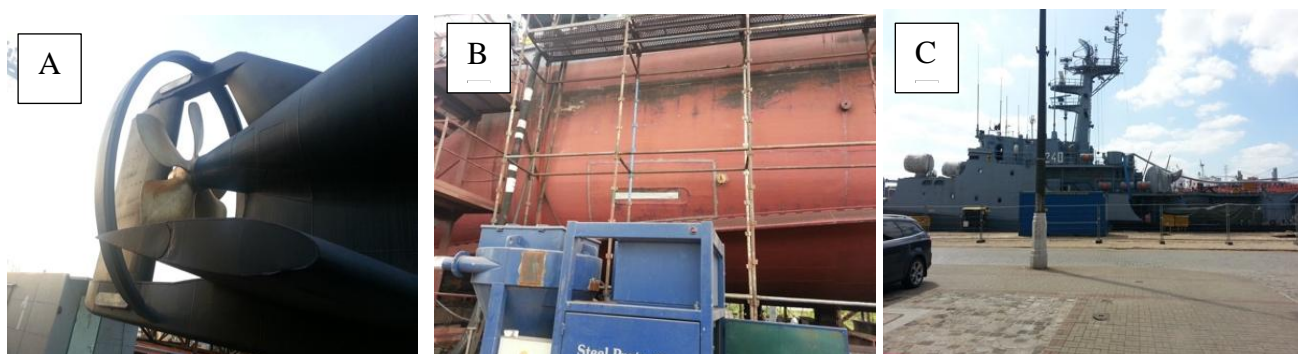
Photo. 4.14. (A) Submarine propeller, (B) Ship in dry dock; on the ship hull, there is a visible screen including the anode, (C) Warship at the quay during polarization tests.

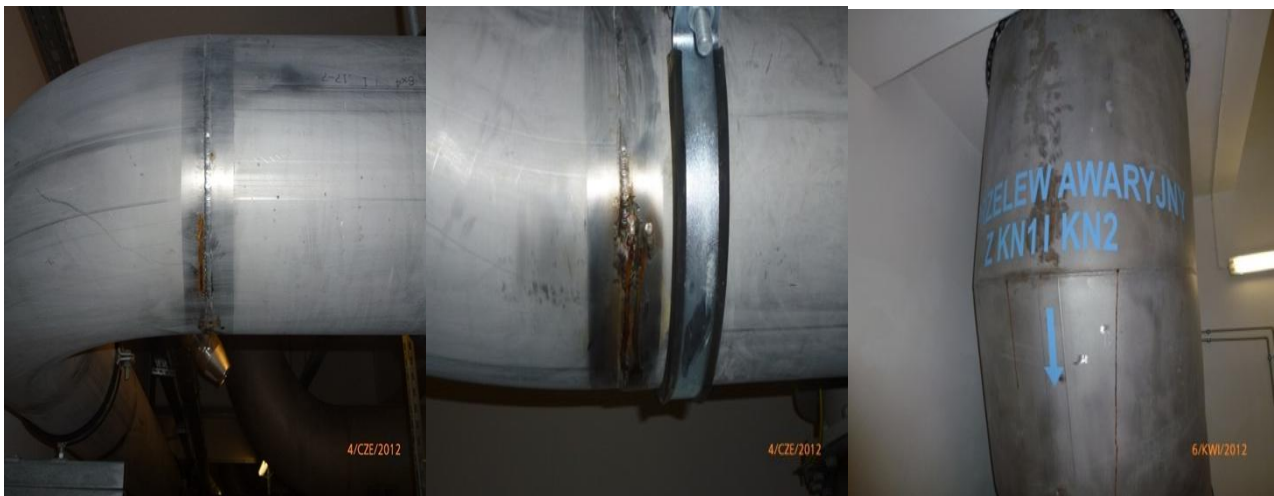
Photo. 4-16. Examples of corrosion damage to 316L steel localized in the vicinity of the welds in an ozonation station

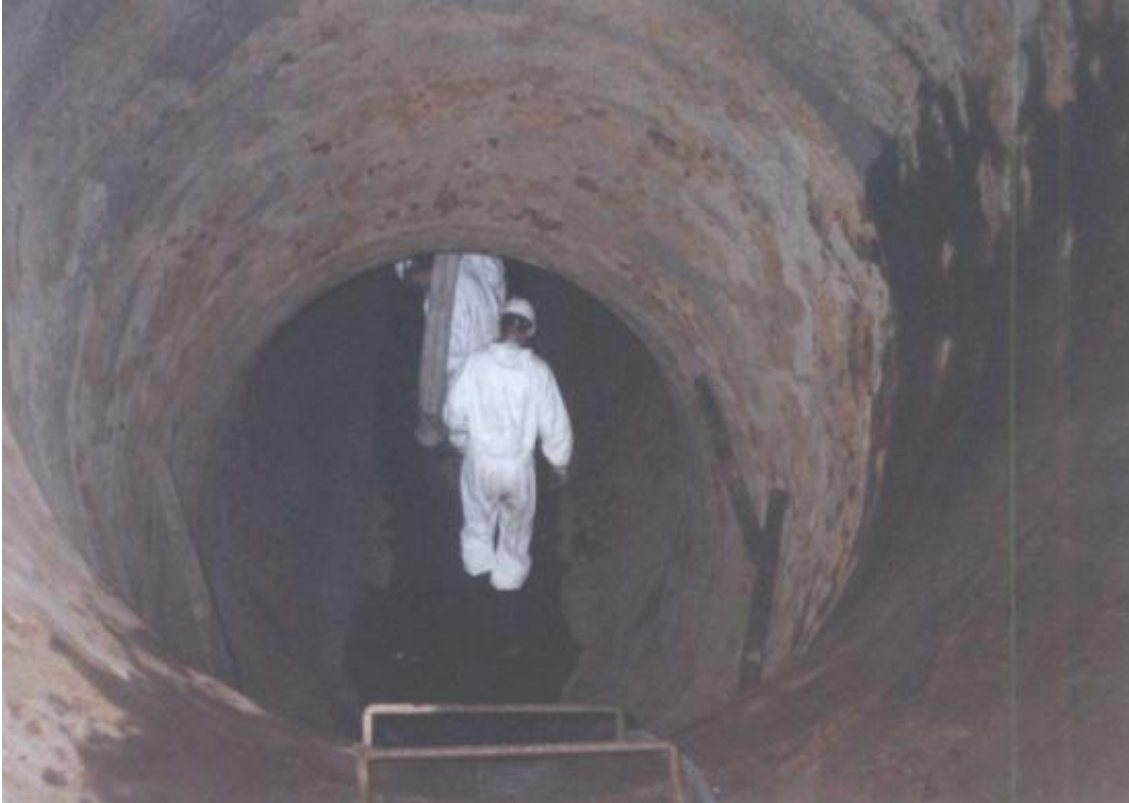
Discharge pipelines evacuate water and steam from the power unit to the cooling tower. From this point of view, it is a critical element of the operation of the power plant. Previous tests and long-term service life indicated the risk of pipeline failures. Management of the Bełchatów Power Plant, in order to anticipate the potential threats of shutting down two power units, took the initiative to determine the actual condition and the risk of failures. Due to the potential serious hazard, research work involved significant responsibility.

Fig. 4-17. Bełchatów Power Plant discharge pipeline and employees of the Department during corrosion inspection

Excluding the discharge pipeline from operation for the period of anticorrosion work would result in huge losses.

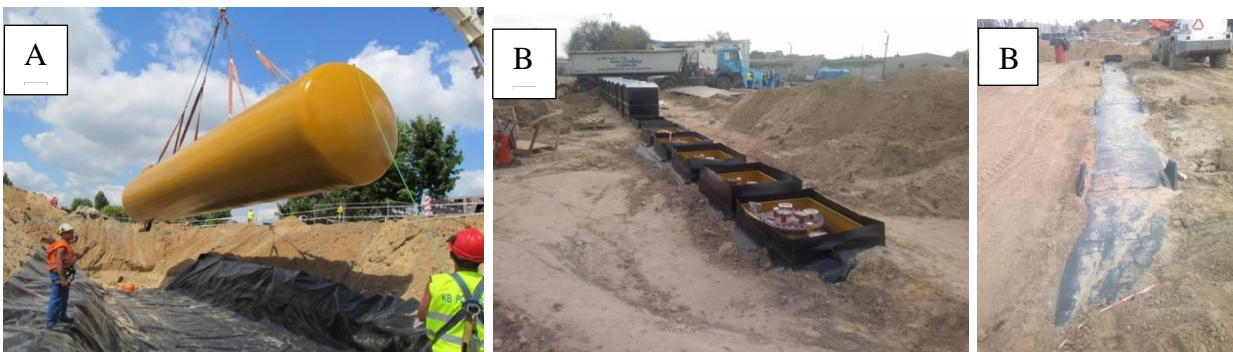
Photo. 4.19. (A) Fuel tank laid on plastic foil, (B) View of installed tanks of a fuel terminal

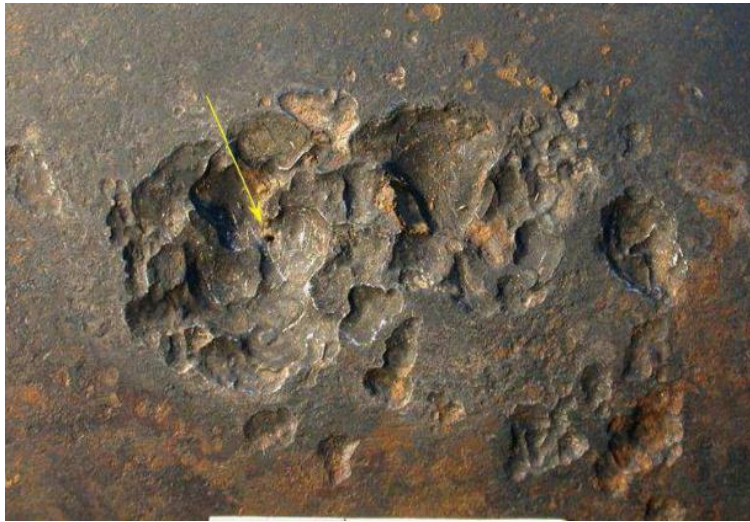
Photo 4.20B. Image of damage as a result of the inductive interaction of a high-voltage line
